# Evaluation of a Portable Laser Depainting System

Marta A. Jakab

Southwest Research Institute

| Report Documentation Page | | | | Form Approved<br>OMB No. 0704-0188 | |
|--|---|---|---|---|---|
| 13. SUPPLEMENTARY NOTES<br><b>2009 U.S. Army Corrosion Summit, 3-5 Feb, Clearwater Beach, FL</b> | | | | | |

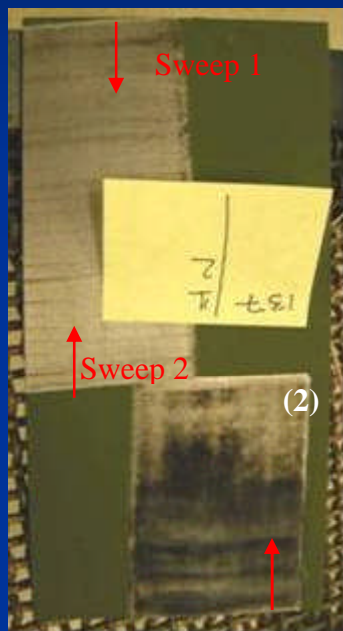
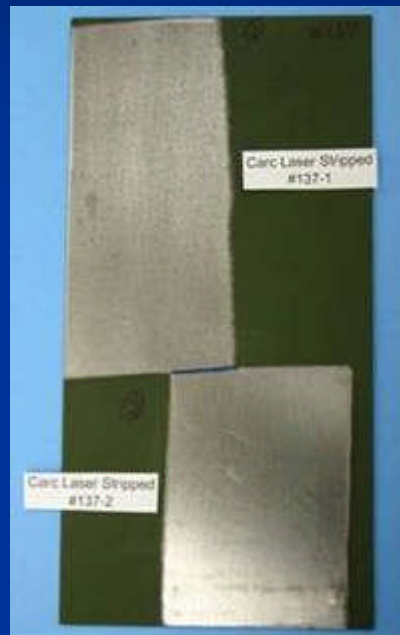
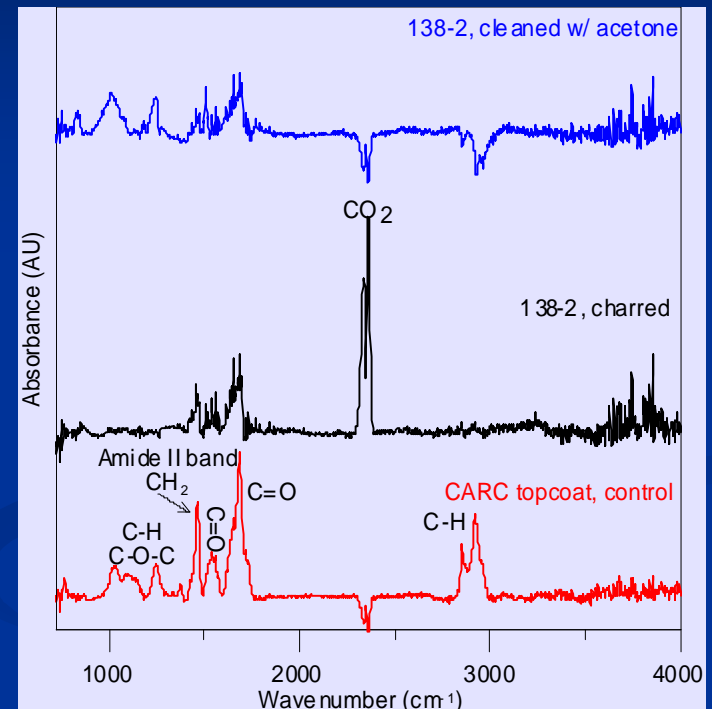
# Coating Removal Efficiency

Cleaning with acetone →

## Laser parameters:

voltage: 3.61 kV, current: 0.75A, beam energy: 0.79 J/pulse,  
gas mixture: 12.5 % CO<sub>2</sub> + 22.5 % N<sub>2</sub> + bal. He,  
distance of end effector from test panel: 3.81 cm

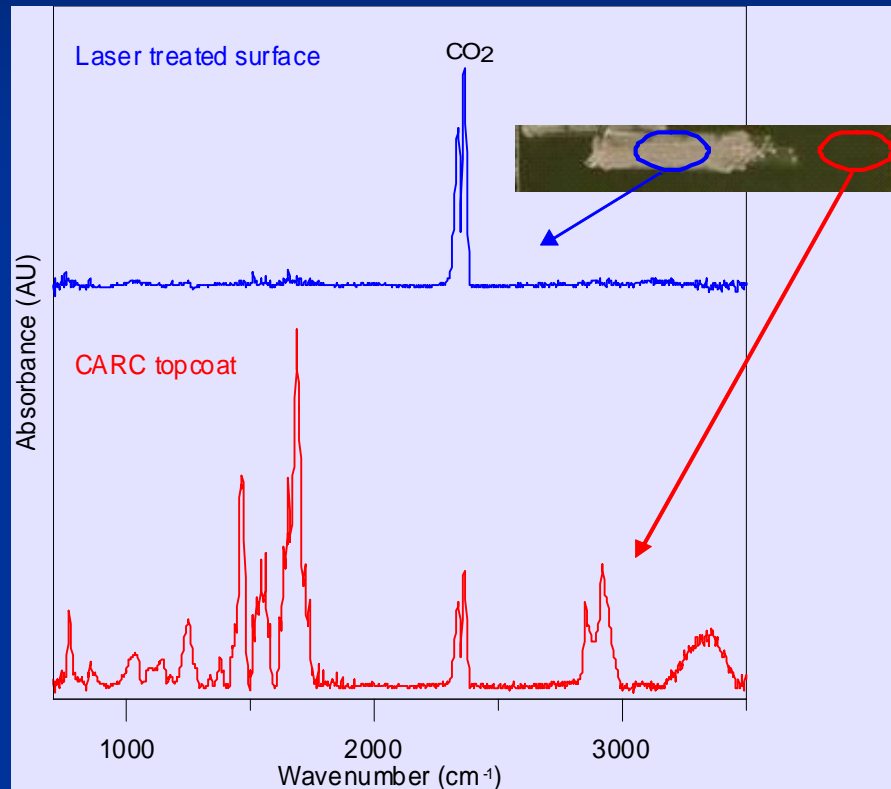
# Coating Removal Efficiency

If no charring is present, coating is removed completely from the surface.

Charring can be avoided by optimizing the laser fluence (optimum range: 8-12 J/cm<sup>2</sup>).

- The laser was found to be efficient in removing CARC with coating removal rates comparable to those of sandblasting. Charring was observed in some cases during laser decoating, probably due to low laser fluence. Paint residue was found on the charred surface indicating incomplete paint removal.

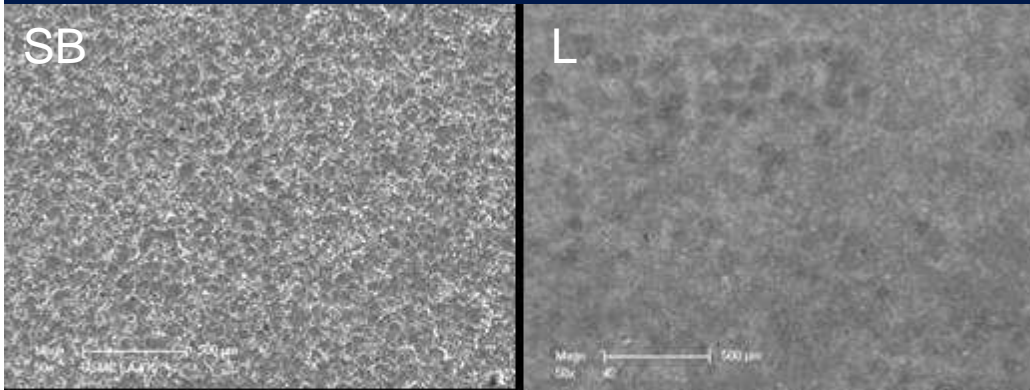
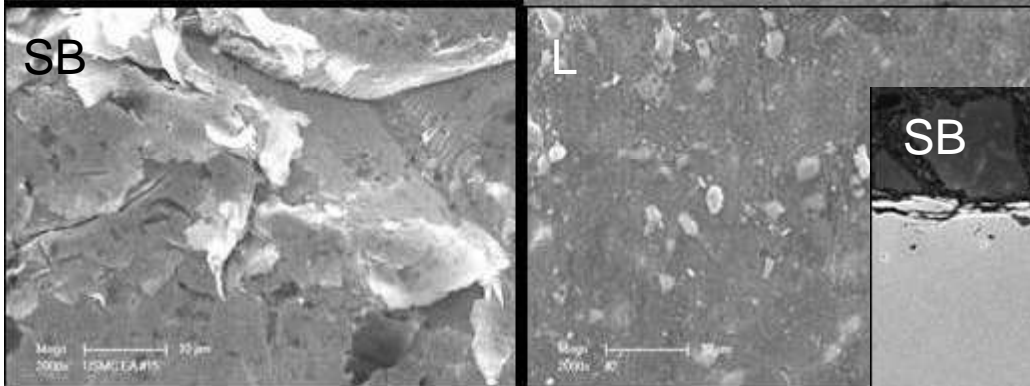
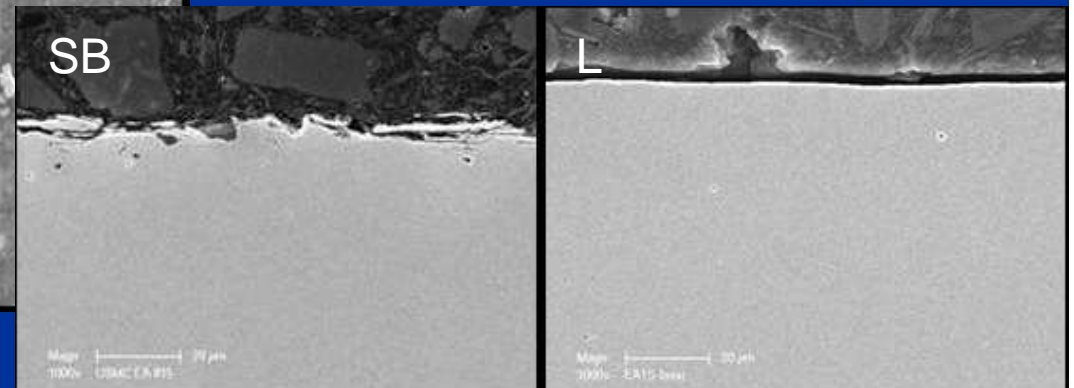
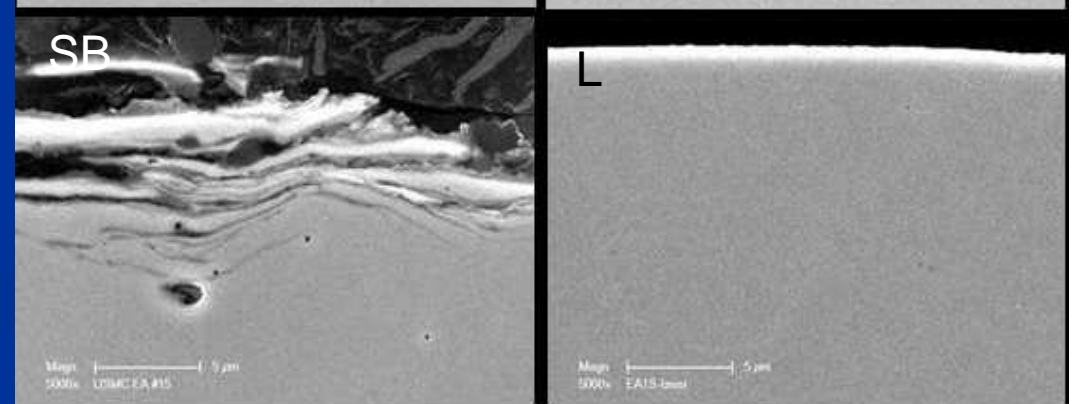
# Surface Erosion and Surface Roughness

Sandblasted: 6.180 µm

Laser Treated: 0.687 µm

- Preliminary studies of selective coating removal showed that the laser can be optimized to remove the topcoat without damaging the primer layer.
- The laser treatment did not affect the surface roughness of the test panels, while sandblasting markedly increased the surface roughness and caused significant damage to the oxide layer. The impingement of high velocity sand particles also led to Si contamination of the surface.

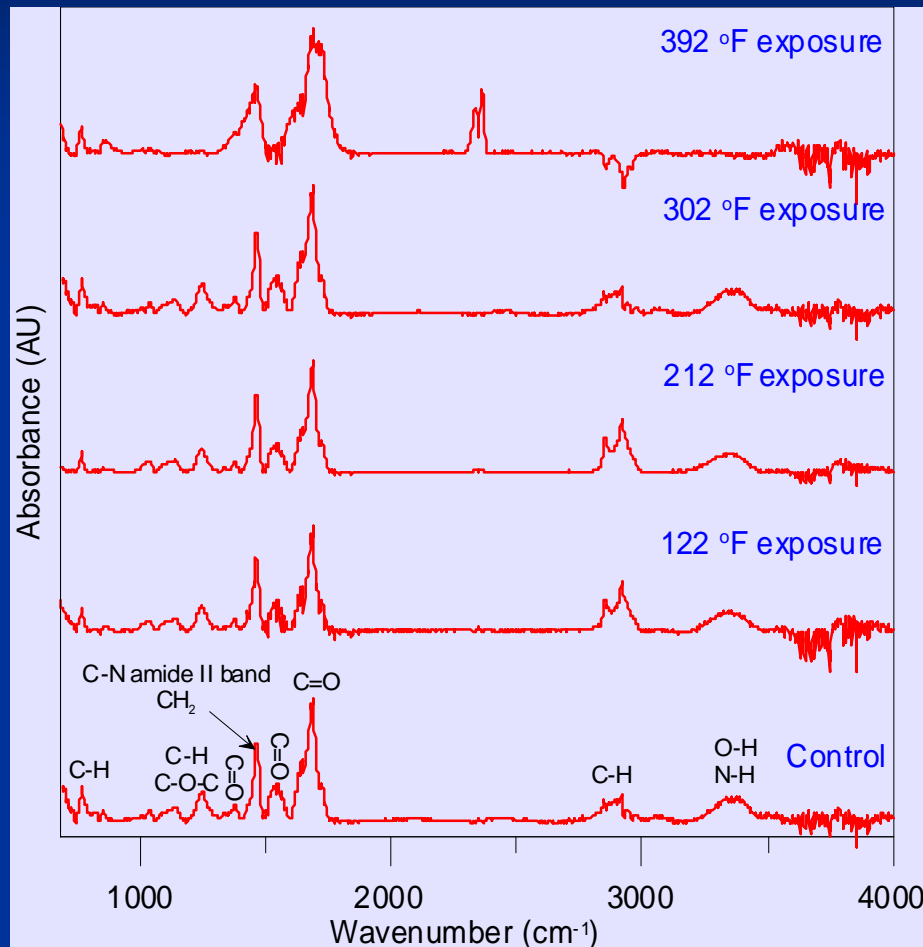
# Thermal Resistance of CARC

No changes in FTIR spectrum (chemical bonds) up to 302 °F.

No damage is expected to surrounding coated areas.

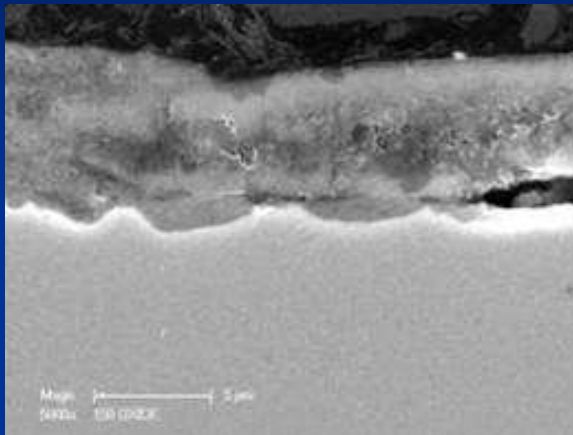
Lightly Rusted Panel:

Fe/O  
= 0.72

BEFORE

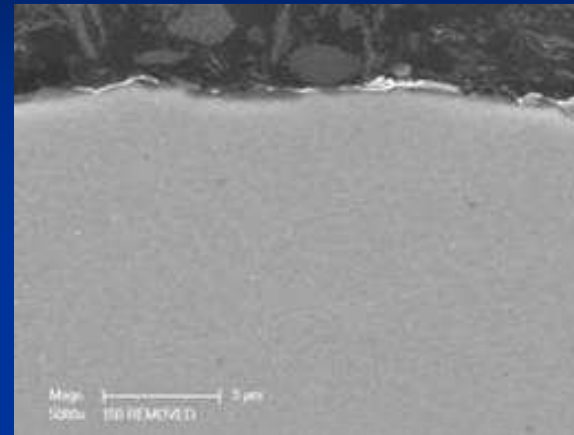
Fe/O  
= 2.73

AFTER

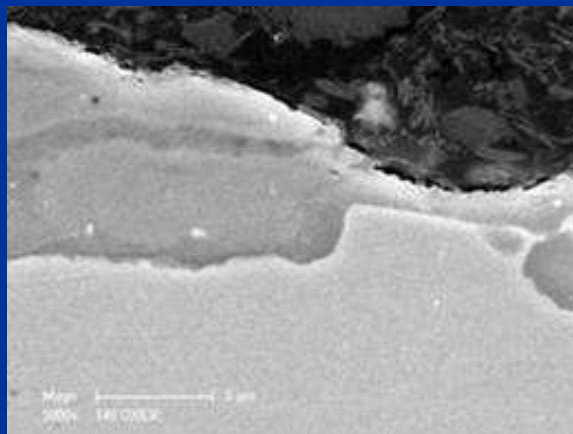
Heavily Rusted Panel:

Fe/O  
= 0.38

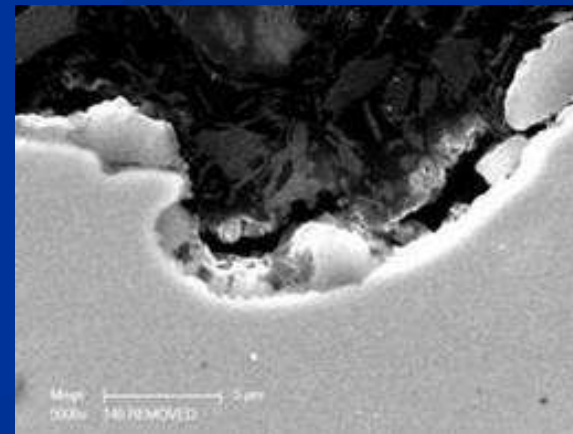
Fe/O  
= 0.58

Thermal load during corrosion product removal:  $T(\text{max}) = 315.20\text{ }^{\circ}\text{F}$
